Re 123 Main Street
Any Town USA

REPORT SUMMARY

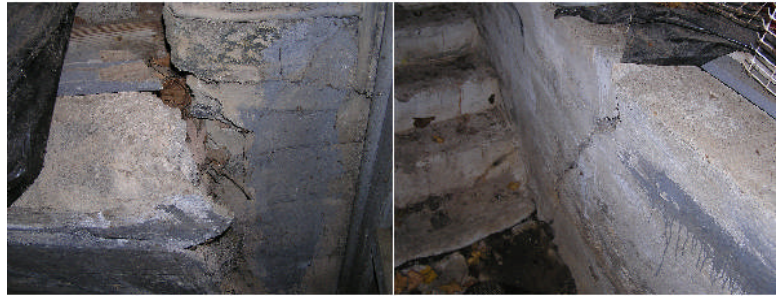
Condition of Wall and Materials Used:

Action Necessary - The retaining wall requires some repair or replacement which is due either to movement or deteriorated materials.

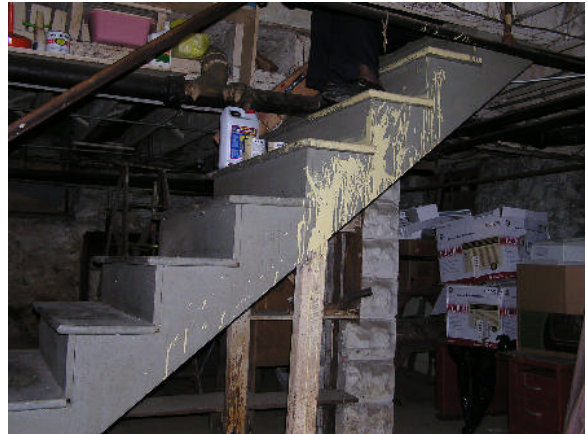
**Staircase
Condition:**

Attention Needed - The staircase needs some attention. The stair stringer is not properly attached to the floor. Only a small portion of the stringer is supported by the floor joist. Additional support is needed where the steps attach to the floor. The open side of the stairway should have balustrade installed.

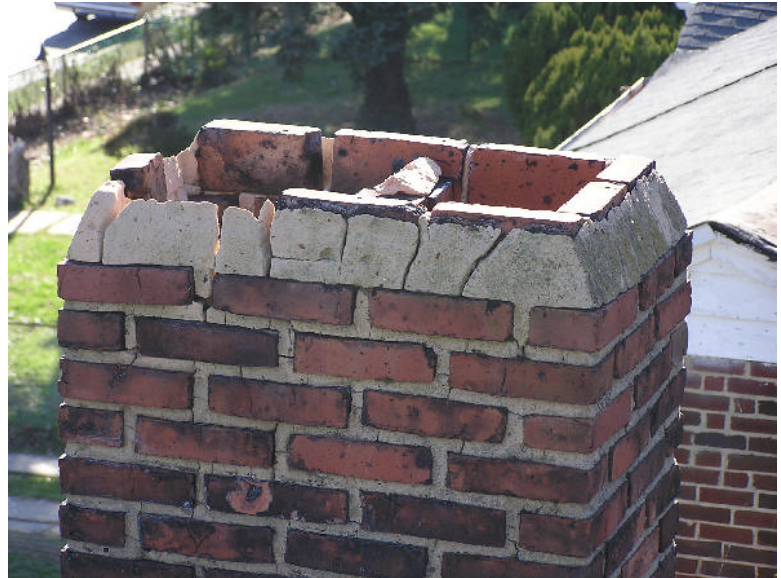
**Exterior Stack
Material:
Exterior Stack
Condition:**

Action Necessary - The exterior stack has a condition that calls for repair. The top of the chimney is deteriorated and needs repair.

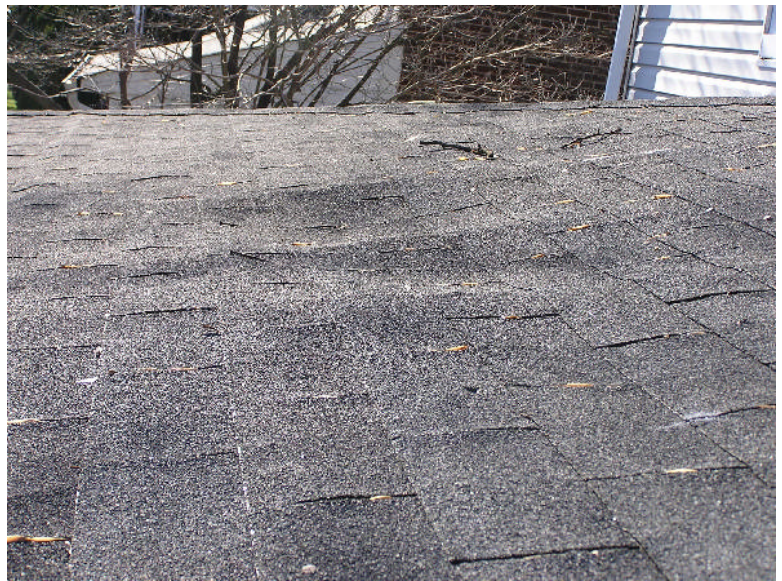
Condition of Roof Sheathing:

There are several low spots on the front porch roof where the roof sheathing has deteriorated. Water may collect in the low spots and eventually leak through the roof covering.

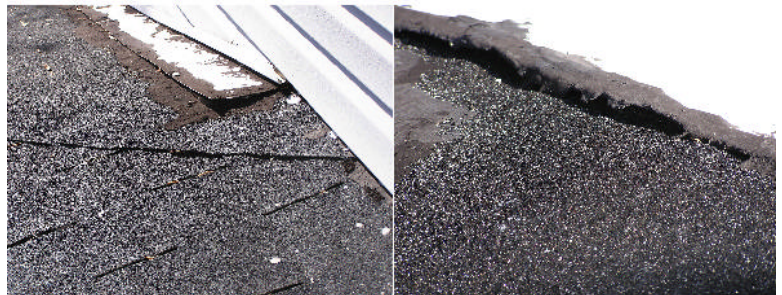
Flashing:

Attention Needed - Some portion of the roof flashing needs to have some repair. The flashing along the flat roof at the rear of the house is raised where it

meets the shingled roof. The flashing on the front porch roof is raised. Caulk is needed against the wall where it meets the front porch roof.

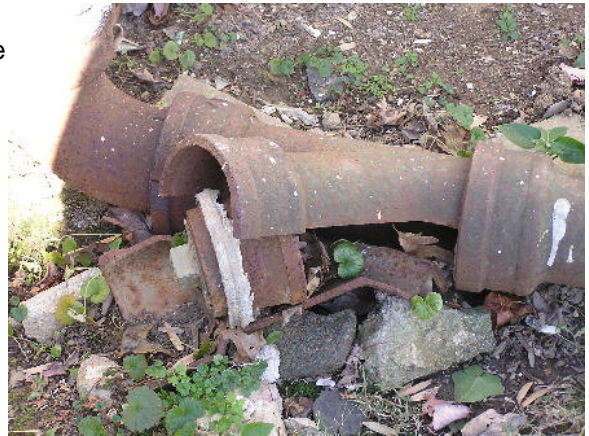
Roof Gutter System:

Installation of down spout extensions would help carry the water further away from the foundation. The gutters need to be cleaned. There is a broken drain at the front left side of the house where the down spout connects to the underground drainage. There are some loose gutter nails.
